TOWNSHIP OF
MAPLEWOOD

PREPARED BY:
EDGEWATER DESIGN LLC.

JUNE 2010

RAHWAY RIVER CORRIDOR STUDY

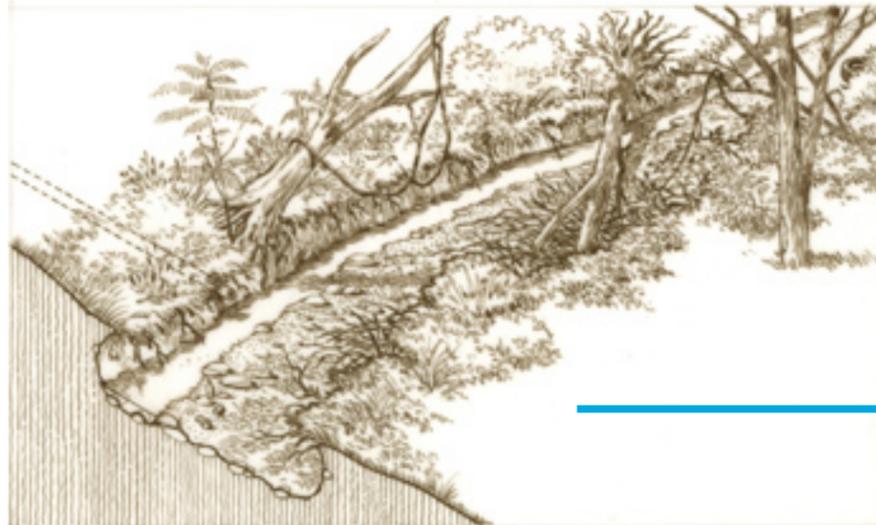
IMAGE OF DEGRADED WATERWAY

The river corridor is degraded as a result of channelization, filling and the construction of stone retaining walls. The riparian zone is degraded due to the loss of vegetation and proximity of structures, including buildings and asphalt surfaces, some of which are at the top of bank.

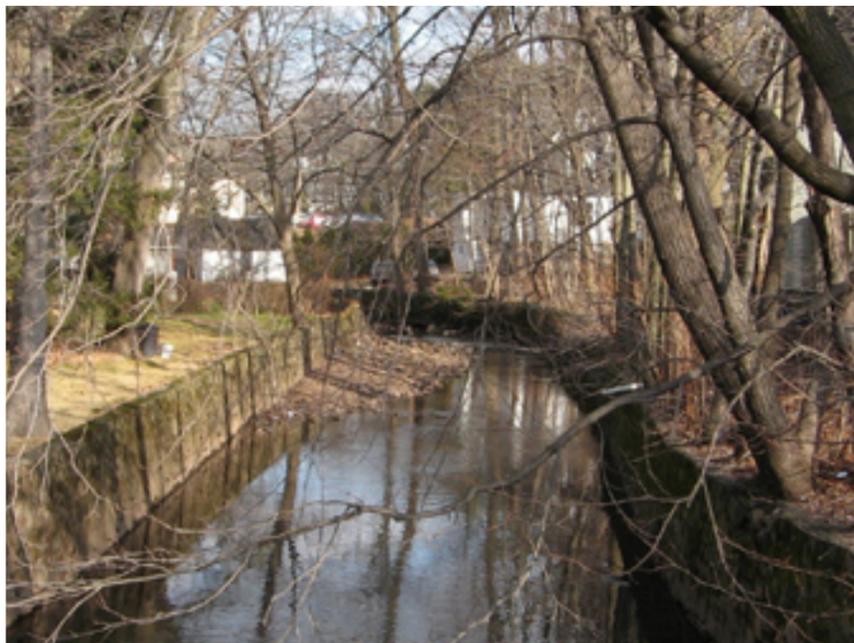
A. The river banks on the southern end of the project consist of hand-laid stone rubble retaining walls, that appear to date back to the 1930s. These walls are approximately 6 to 8 feet in height and exhibit varying degrees of distress. Of significant concern along the walled sections is the cutting of the riverbed along the wall resulting in undermining of the foundations. In some areas, development, including structures, extend up to these walls.

In 1974, Frank H. Lehr Associates prepared plans for limited repairs to address foundation undermining. Based on these plans, it appears that the original stone wall construction extended approximately 18" below the bottom of the river. The 1974 project included an underpinning like placement of concrete at the toe of the rubble wall, to restore support to the masonry structure. Limited sections of wall, primarily in Memorial Park were totally replaced. Here, concrete footings extending to a depth of 3' below the river bottom were placed and a new stone rubble wall, including wall drainage, was constructed.*

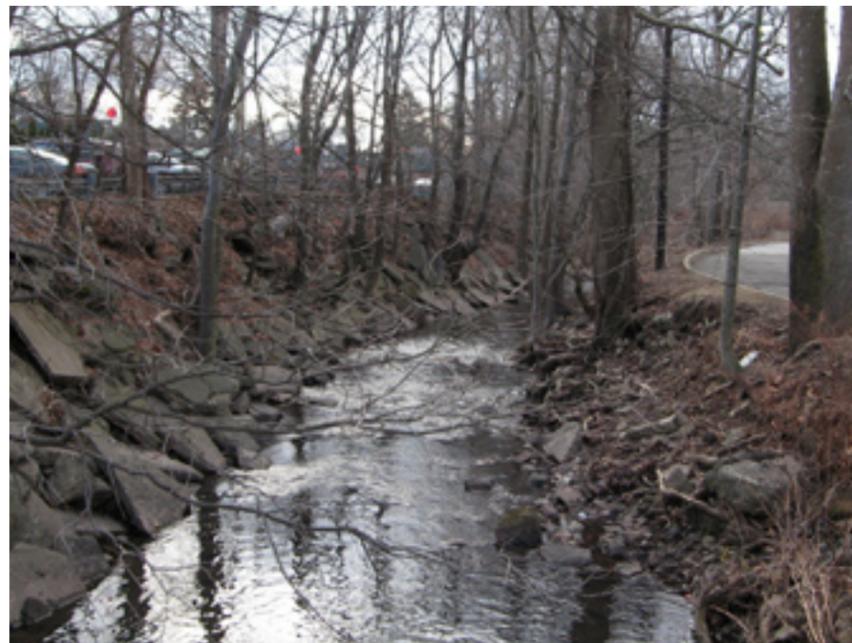
B. The river transitions to a steep natural bank near Jefferson Street. From Jefferson to Parker Avenue West, cracking along the top of bank indicates a global slope stability problem along the westerly bank. There is evidence that this section of stream was previously walled, and the walls have completely failed. Banks in this area are "stabilized" with rip rap from remnants of the old wall, natural stone, and broken sidewalk panels. In this area, it will likely be necessary to cut back the slope and restabilize with natural materials, such as wattling, bio-logs, and living stakes.

The east bank of the river in this section is significantly steeper than the west bank through this area. Here, development along the top of bank (Maplewood YMCA) will prevent flattening of the slope. Similar to the west side, it appears that the stream was previously walled, and the walls have completely failed. Banks in this area are "stabilized" with rip rap from remnants of the old wall, natural stone, broken sidewalk panels, and dumped asphalt. In this area, some form of structural stabilization will likely be necessary.*

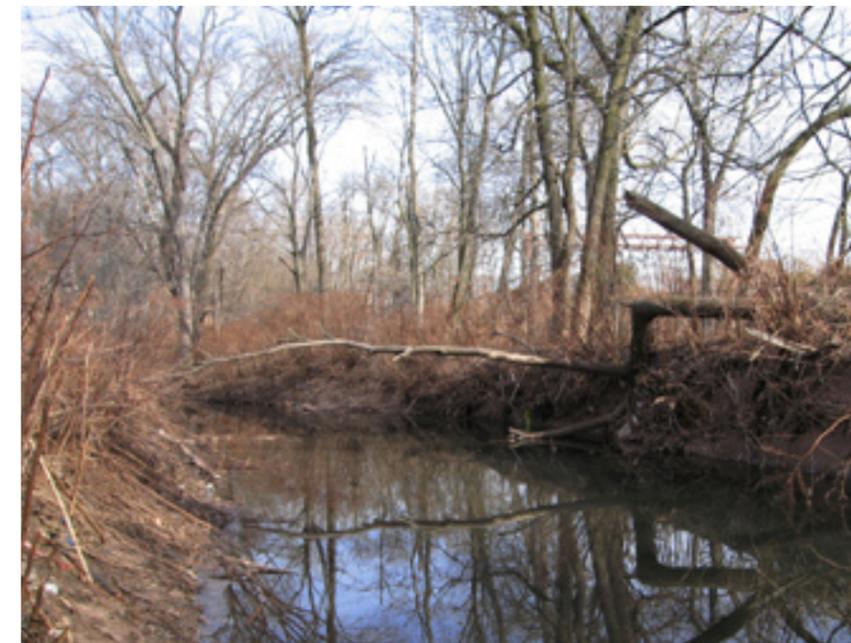
C. Beyond Parker Avenue West and extending up to Chyzowych Park, the river transitions to a flatter, natural bank. In this area primarily natural bank cutting was observed. Here, work will likely be limited to a desnagging program to removed dead vegetation and debris blocking the channel. In some areas, natural bank stabilization methods may be used to supplement areas of sparse vegetation.

Throughout corridor, stabilization and repairs should be anticipated at storm water discharge points such as headwalls and drainage ditches.*

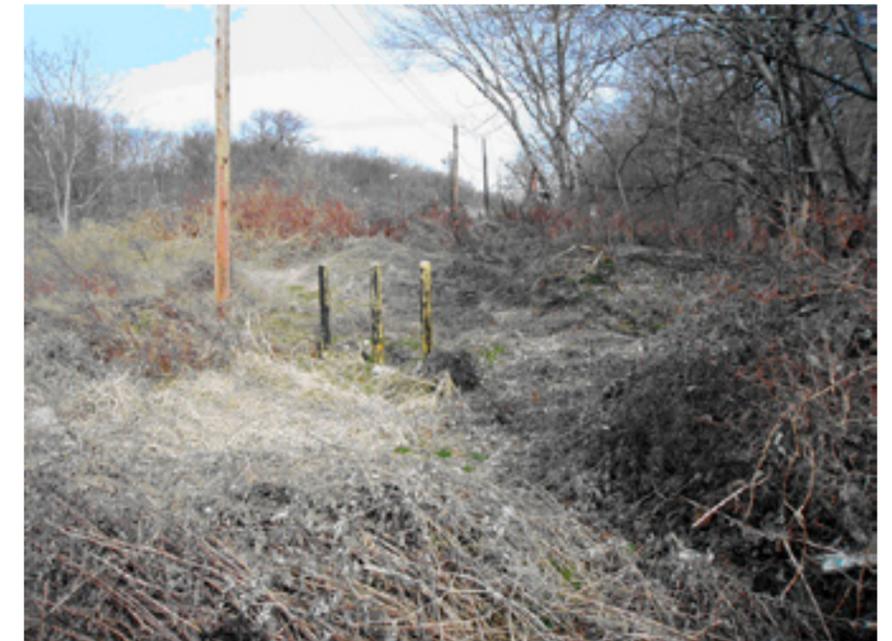
F. View facing north of area of early successional field (Block 15.07; Lots 419 & 343) north of the Board of Education parking lot. This degraded area has the potential to provide additional riparian zone restoration.

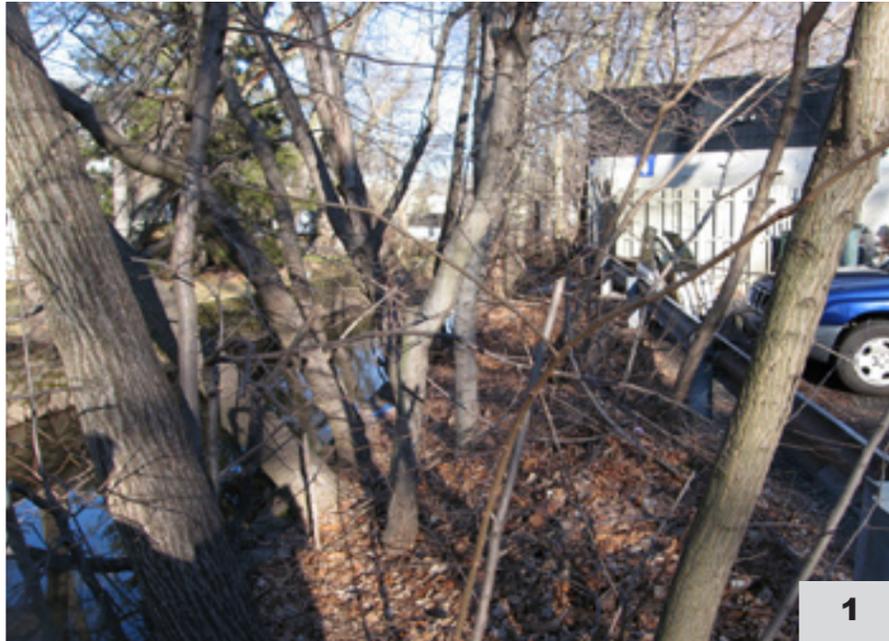
1
The river channel at Oakland Avenue has vegetated slopes on the east and access is limited due to private property and existing buildings, trees and slopes. In this case, it is recommended to direct people onto nearby Dunnell Road.

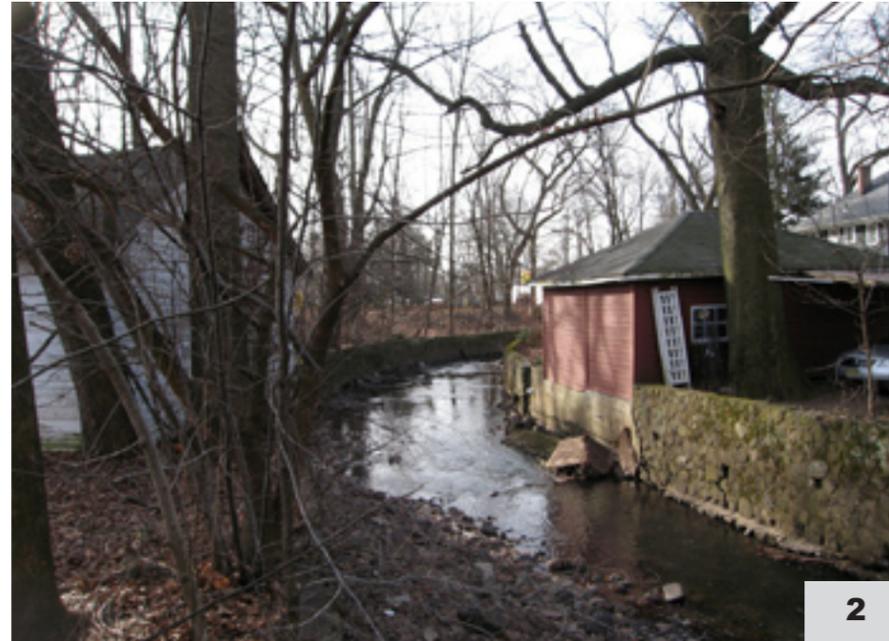
2
The river channel has stone walls with flat slopes along the residential west side and varying vegetated slopes along a majority of the east side. The wall is showing severe signs of undermining due to age and frequent storm events. River access would be difficult due to private property and tight conditions.

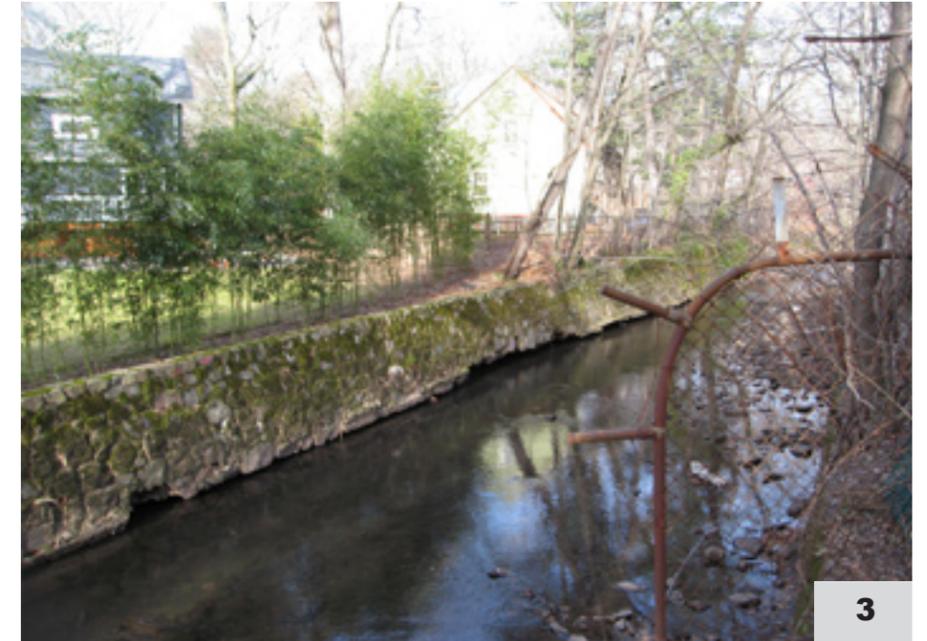
3
The river channel has stone walls with flat slopes along the residential west side and varying vegetated slopes along a majority of the east side. The wall is showing severe signs of undermining due to age and frequent storm events.

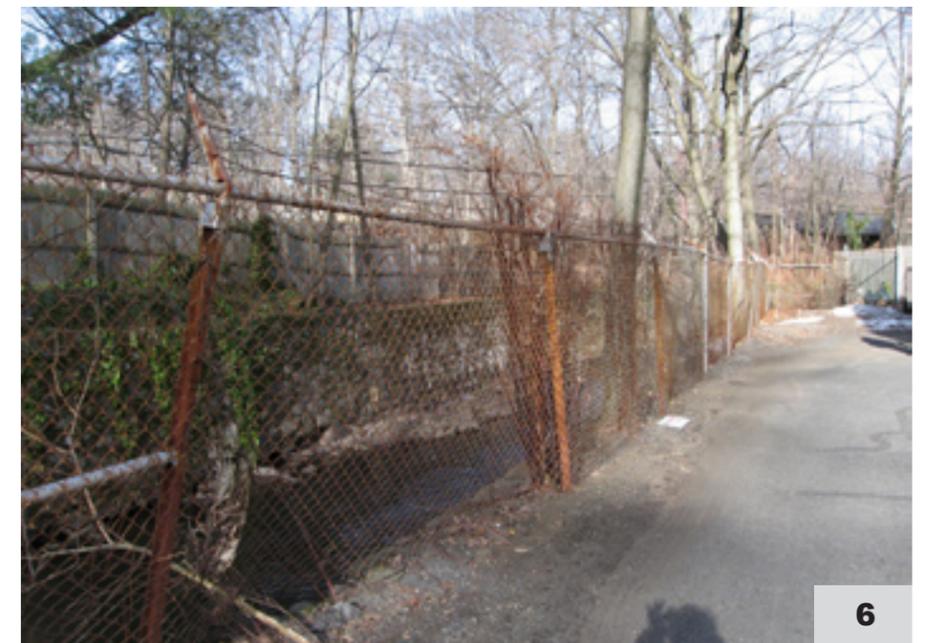
6
Behind the Map Building, pavement is within 3 feet of the walls and old rusted barbed wire fence hugs the space between. Consideration should be given to removing this fence and replacing it with a new design standard such a wood or decorative metal.

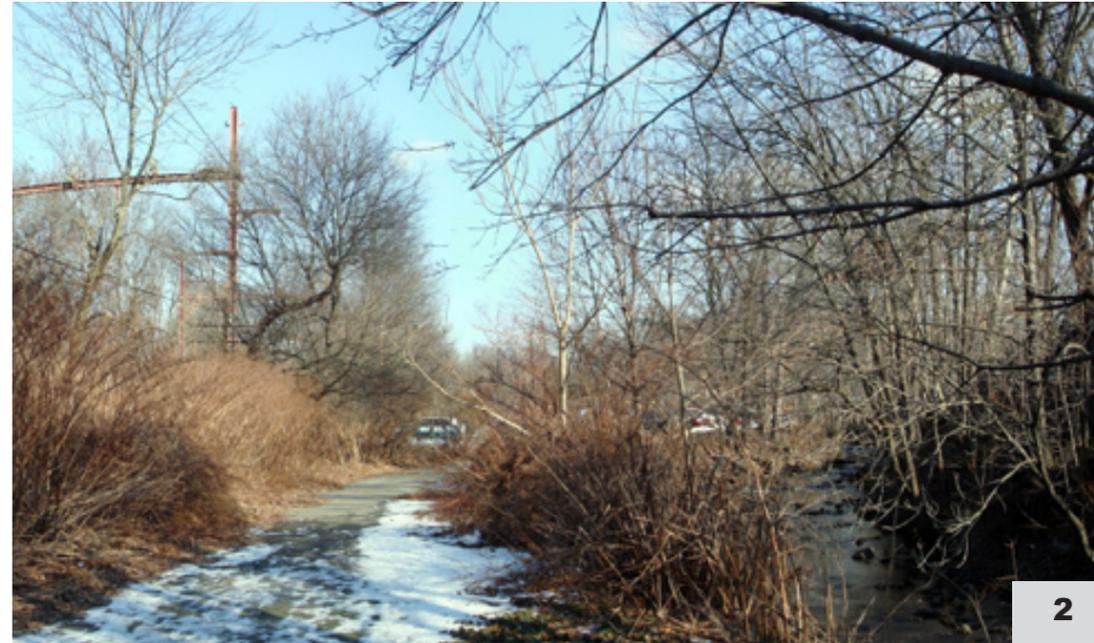
2

The paved lane adjacent to the river and railroad between Jefferson Avenue and the Board of Education parking lot is abandoned, overgrown with invasive plant species and in some places dangerous due to failing and eroded slopes. This area is ideal for landscape renewal and access to the river with biking and walking paths, regenerative planting restoration and reduced steep slopes.

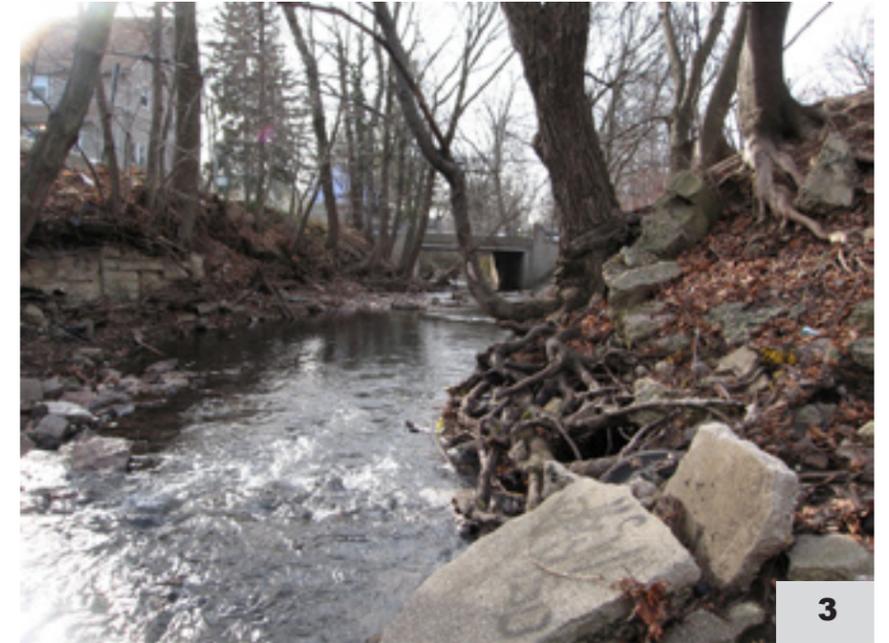
3

The river channel is highly degraded in this zone. However, some large trees with extensive root systems inhabit the slopes and should remain. Where possible per regulations, slopes should be repaired and revegetated with native shrubs and trees.

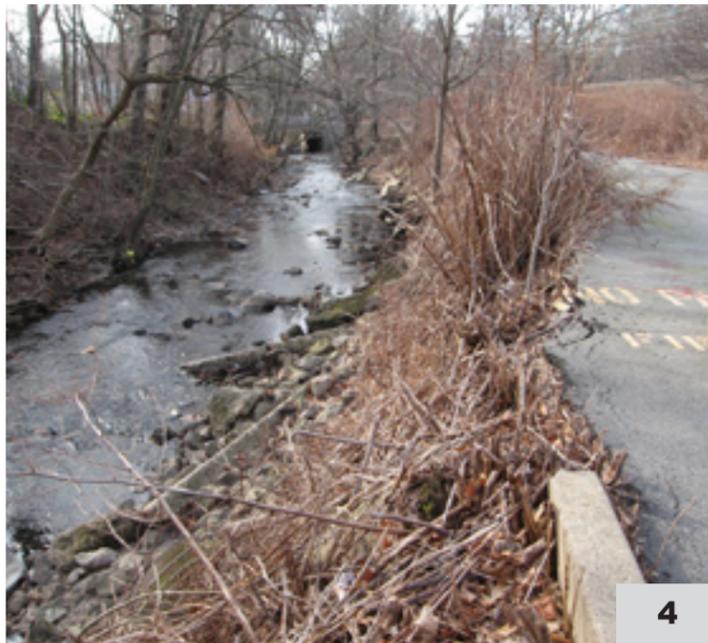
4

In several locations along the river the slope is severely eroded and in some cases failing making it unsafe. Reducing the paving width and returning space back to the river side slopes with improve safety, reduce erosion and increase access.

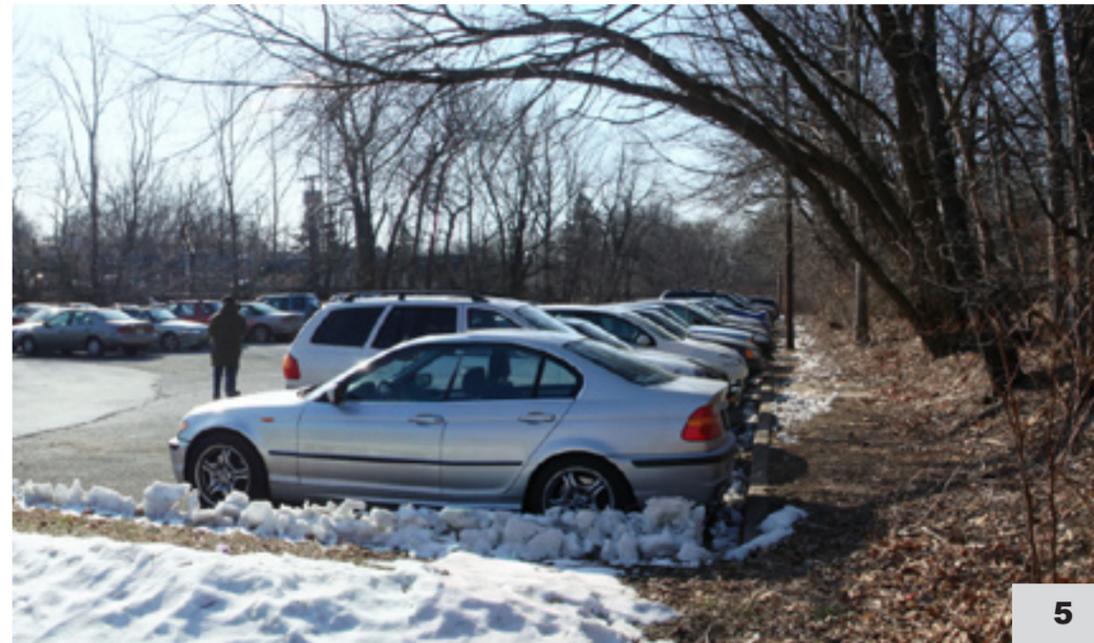
5

The Board of Education parking lot should be restudied for the required amount of spaces as well as the relocation of the spaces to nearby locations. This would free up high-value open space adjacent to the river that could be converted to park, open space with direct river access, opportunity for regenerative planting restoration and stormwater management.

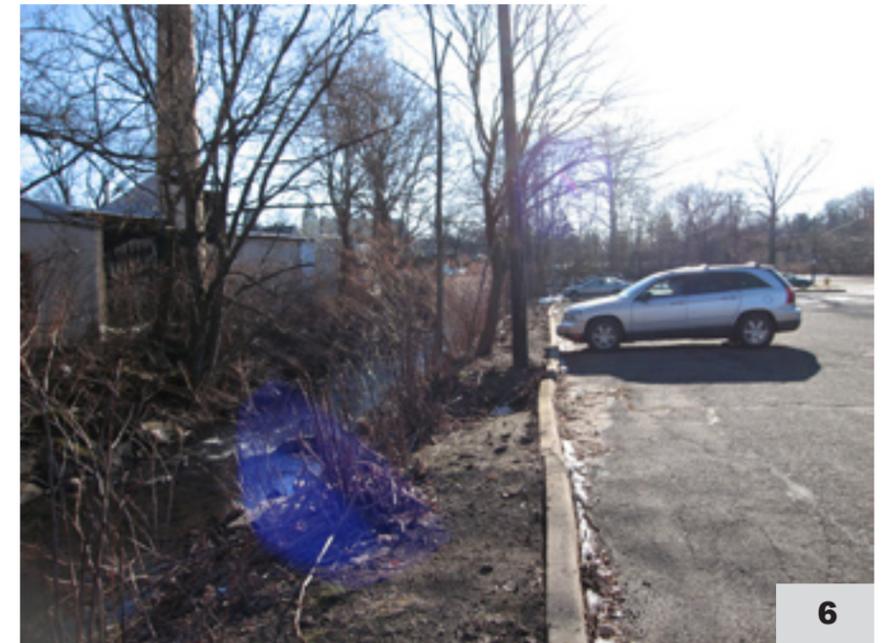
6

The Board of Education parking lots were constructed during a time when permitting was less stringent for how close you can pave within a waterway. This has cut off access to the river as well as degraded and destabilized the slopes. Effort should be made to minimize parking/paving along the river.

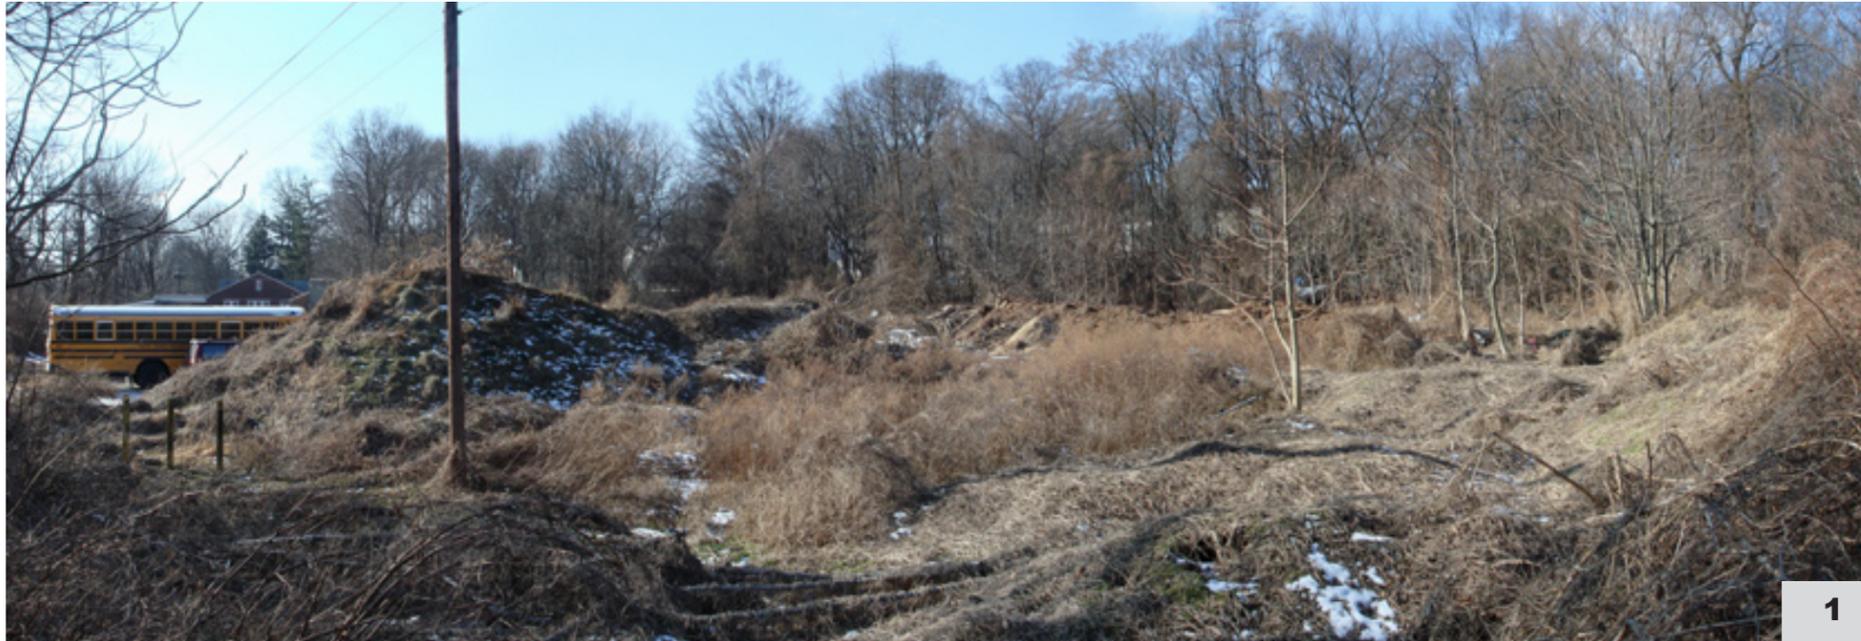
1

Behind the Board of Education Maintenance Building and south of Chyzowych Field is a large former dumping area overgrown with invasive vines, shrubs, and tree saplings. The area is almost one acre in size and will need some environmental testing to determine if there are any contaminants that require removal. This expansive space could be converted into a functional and beautiful amenity space such a community garden or park adjacent to the river for the township.

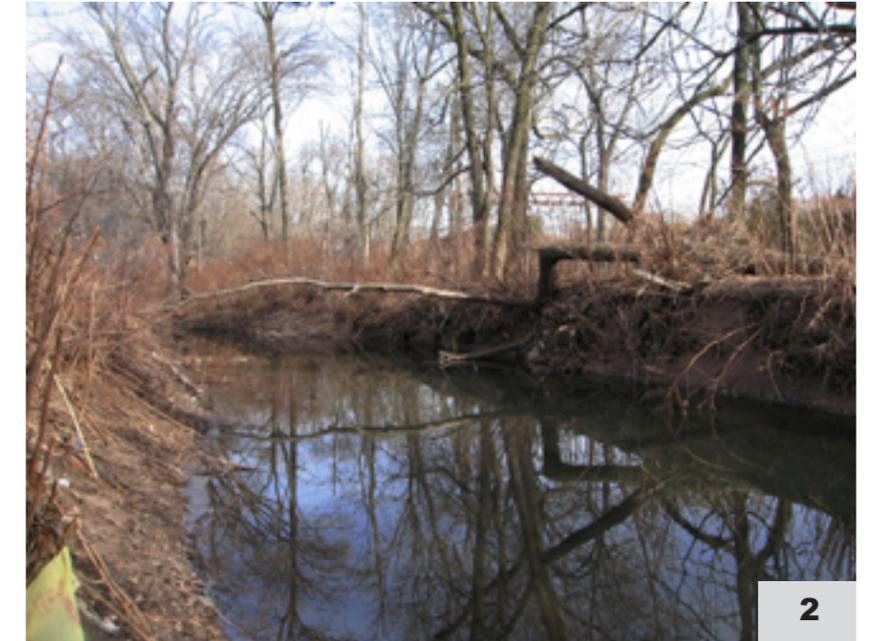
2

The river channel slopes are highly eroded and invasive species rampant. Where possible per regulations, slopes should be repaired and revegetated with native trees, shrubs and perennials.

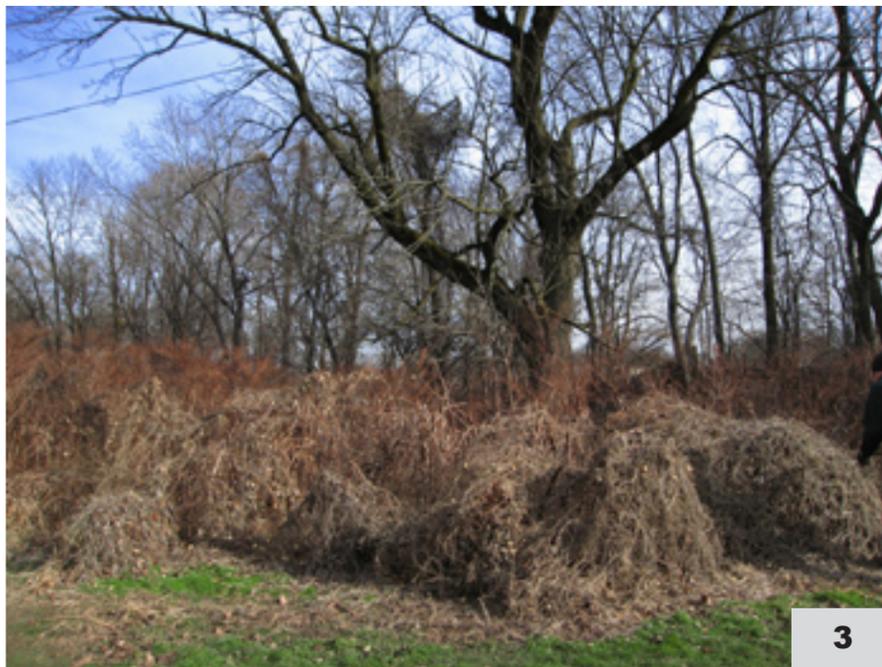
3

Aside from some large shade trees along the field and river, the dominant understory plants are invasive japanese knotweed and vines. Consideration should be given to renewing this landscape along with path access to the river.

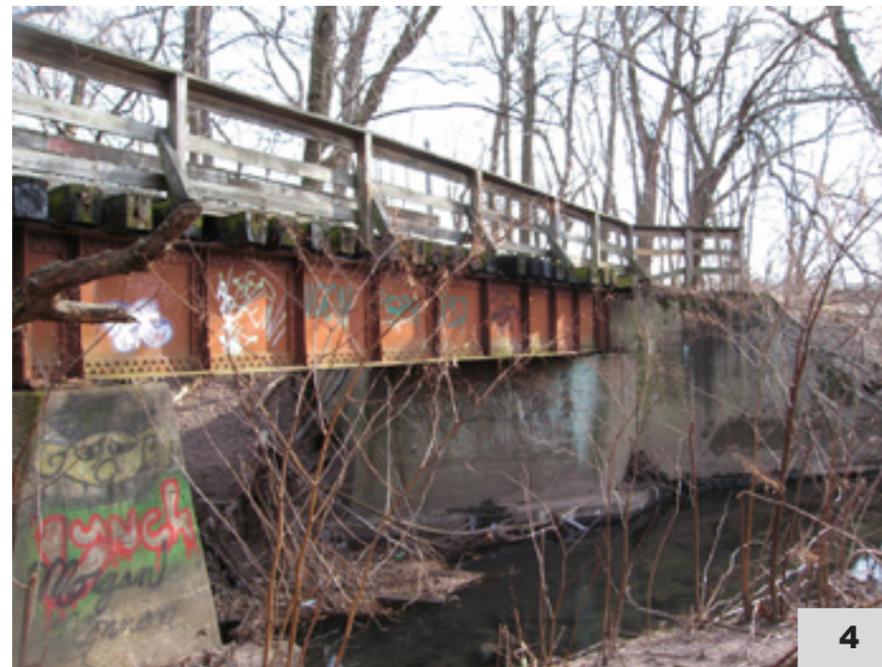
4

The existing steel and concrete bridge just north of the field could be a main pathway connection point for the river improvements happening in South Orange. The bridge provides elevated views north and south of the river.

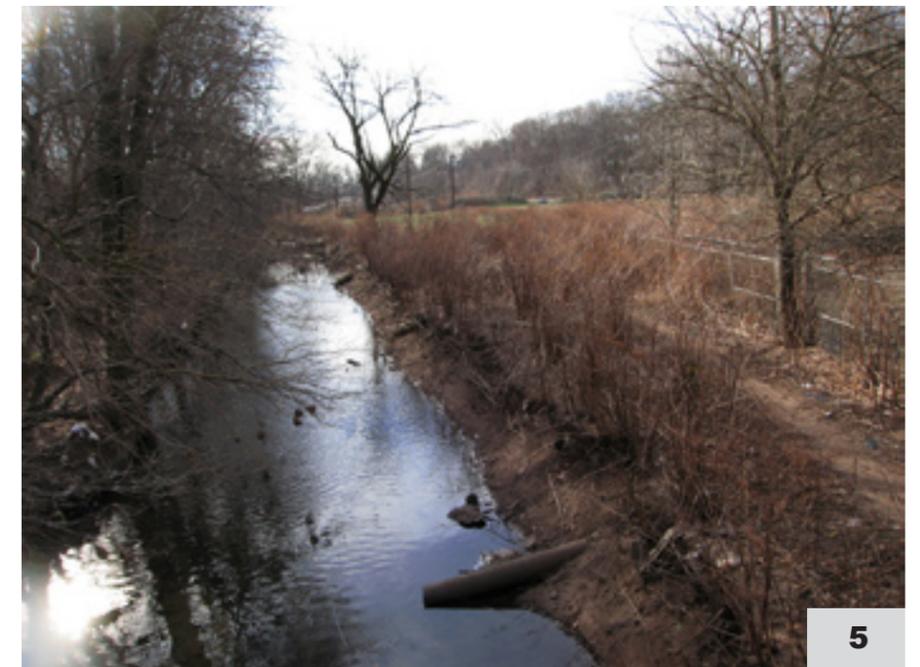
5

Looking south toward Chyzowych Field, the nearby dirt path and landscape is highly degraded and overgrown with invasive shrubs. Consideration should be given to renewing this landscape along with path access in coordination with the Village of South Orange.
